**Property Inspection Report for:**

**160 Some St, Portland, OR 97132**

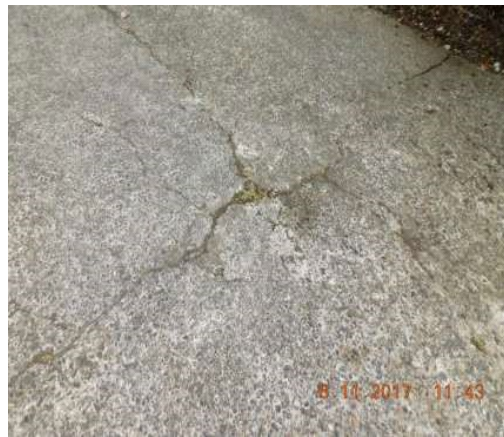
1

### 1.2.1 Moderate Cracking (M)

Cracks may allow water or pests to erode the supporting ground under the concrete, which may cause additional cracking and movement.

Suggested Action: Seal cracks in the concrete driveway with an appropriate sealant.

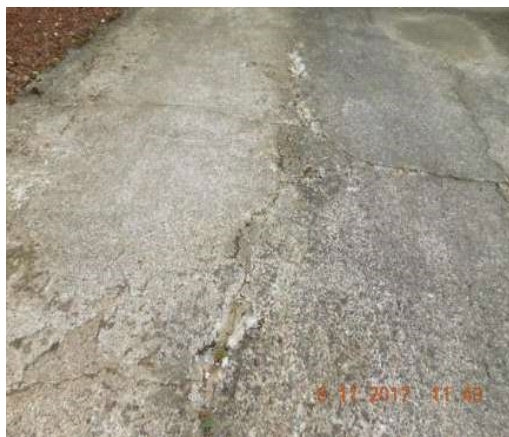
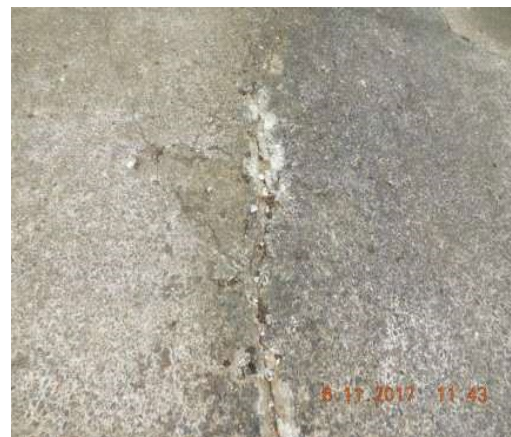
### 1.2.2 Deterioration (M)

Some deterioration of the driveway was noted. Deterioration tends to get progressively worse over time.

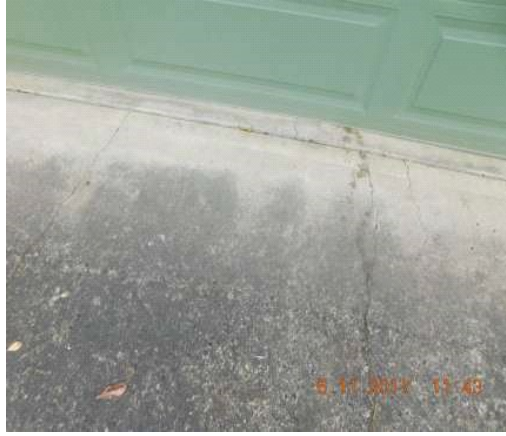
1

### 1.2.3 Common Cracking (M)

It is typical for concrete to develop some cracks over time and is usually not cause for concern.

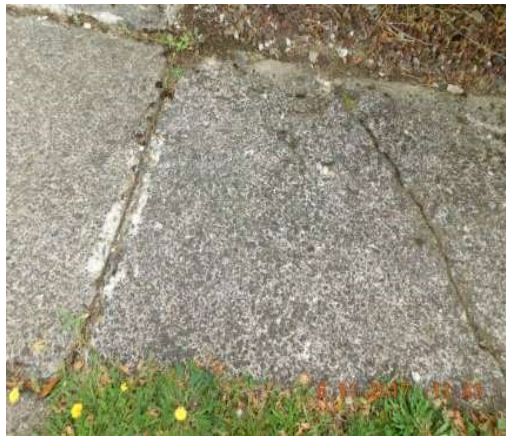
1

#### 1.3.1 Cosmetic Damage M

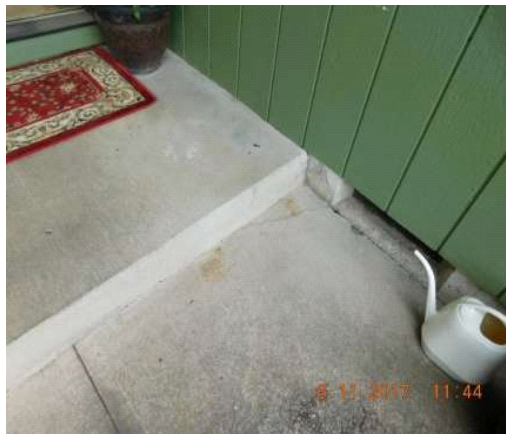
1

#### 1.3.2 Common Cracks M

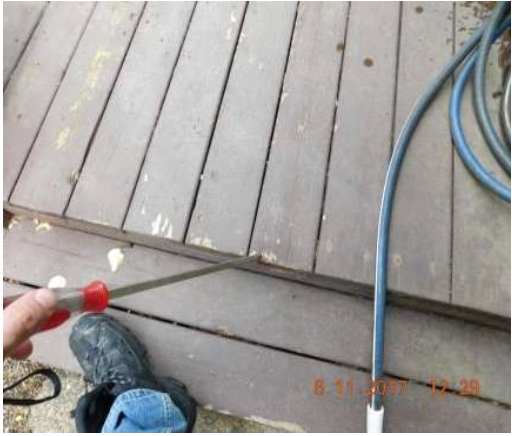
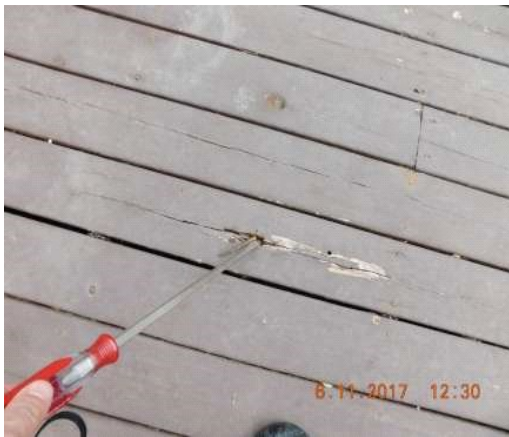
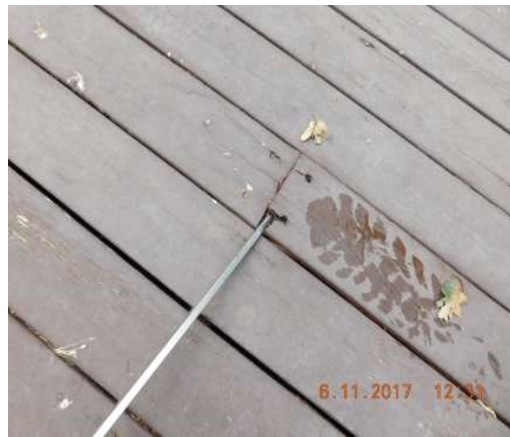
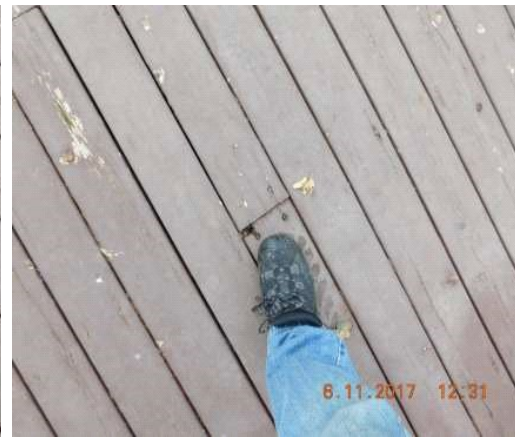
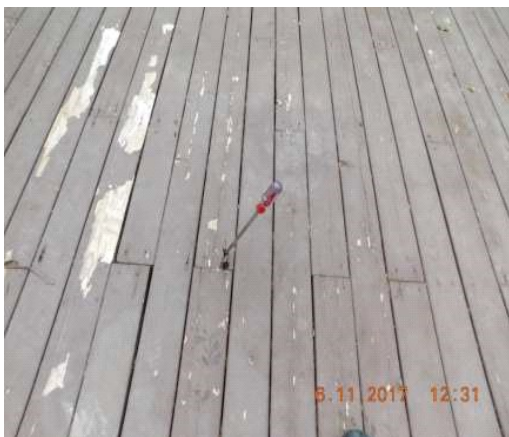
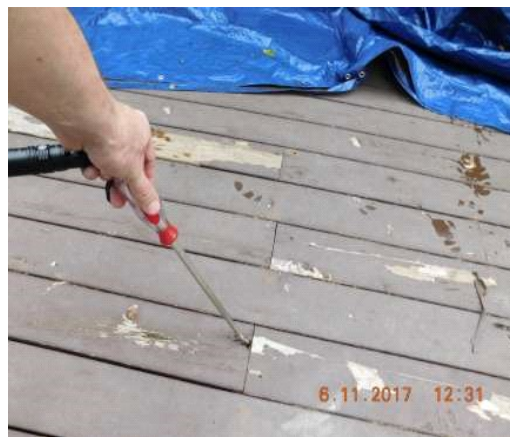
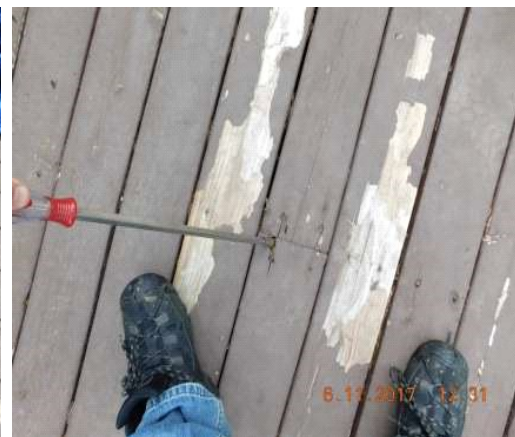
### 2.1.1 Rot At Walking Surface **R S P**

Rot can weaken the surface strength, creating a fall-through or tripping hazard.

Suggested Action: Replace all rotten wood at the deck.

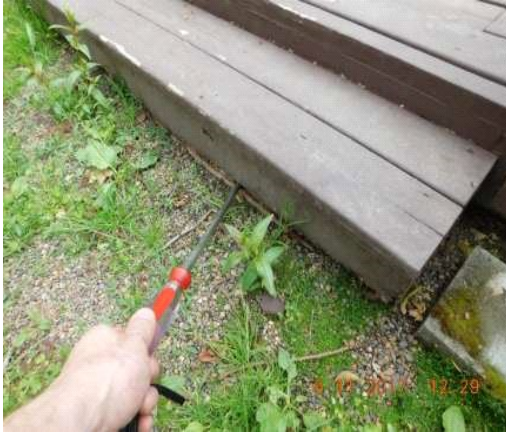
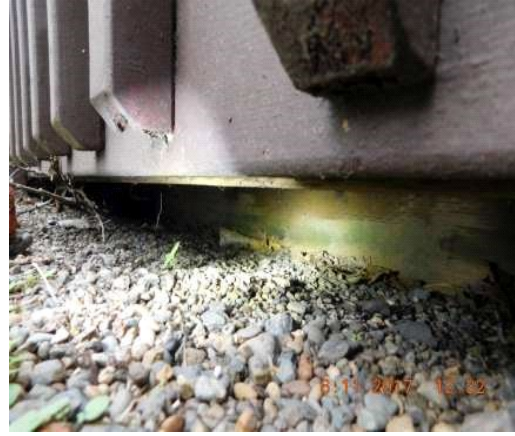
### 2.1.2 Earth To Wood Contact **R P**

Earth in contact with wood will rot the wood and may attract pests.

Suggested Action: Remove soil / accumulated debris from contact with any wood at the deck.

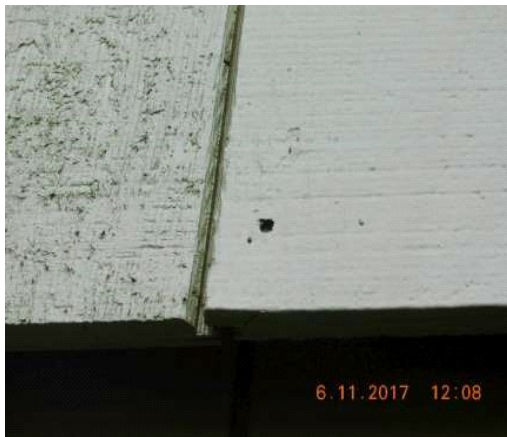
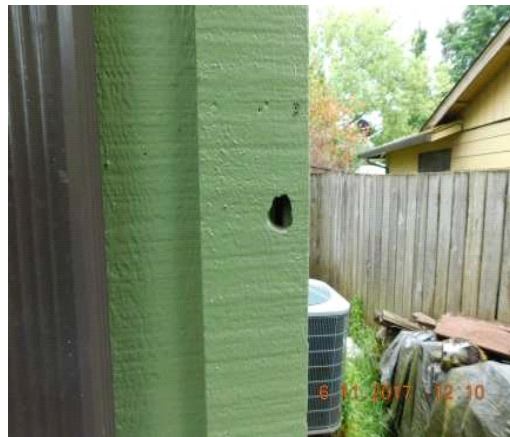
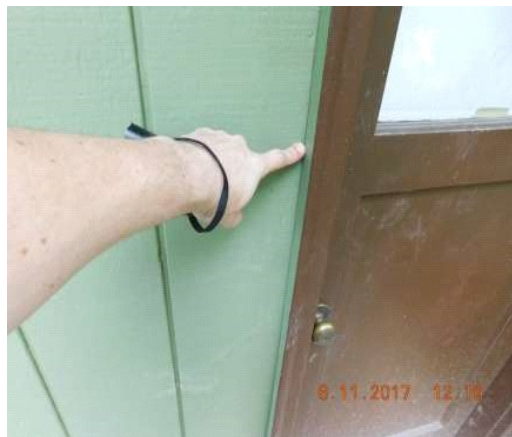
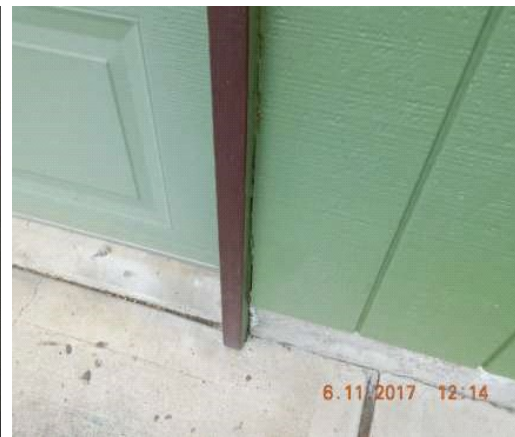
### 3.1.1 Sealant Needed <sup>®</sup>

Suggested Action: To protect the siding and walls from water damage, seal all holes, gaps, cracks, overdriven nail heads, and other points of water entry.  
Replace deteriorated / separated caulking or sealant.

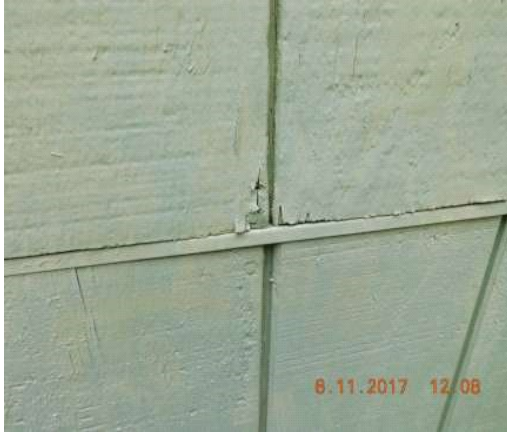
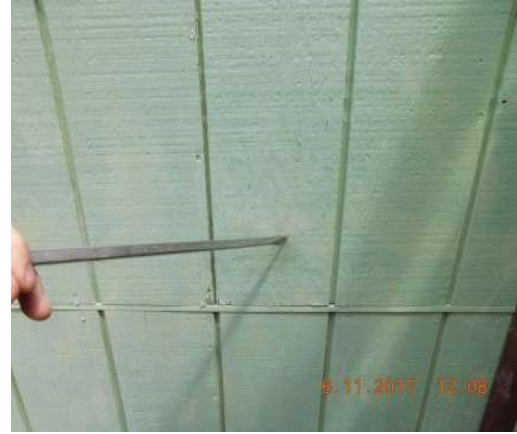
### 3.1.2 Rot At Siding <sup>®</sup>

Suggested Action: Remove rotten siding at the garage side and patch or replace the siding.

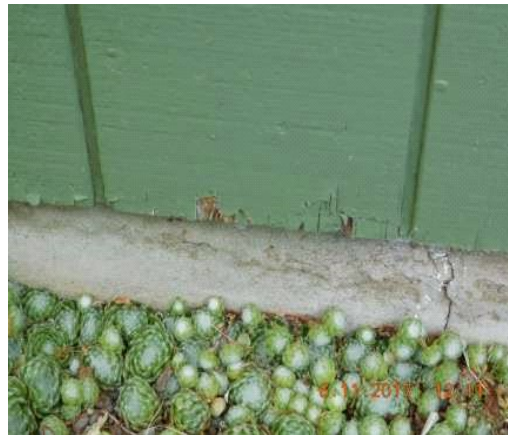
1

### 3.1.3 Paint Needed <sup>®</sup>

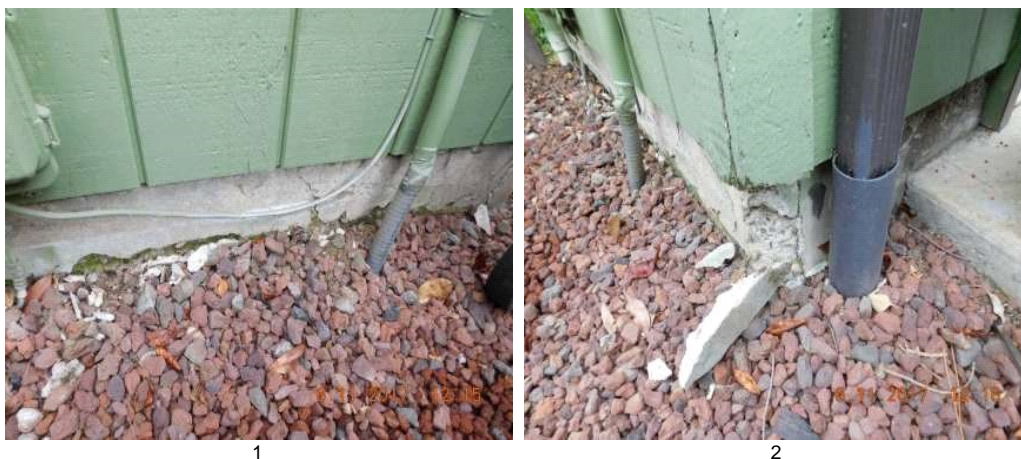
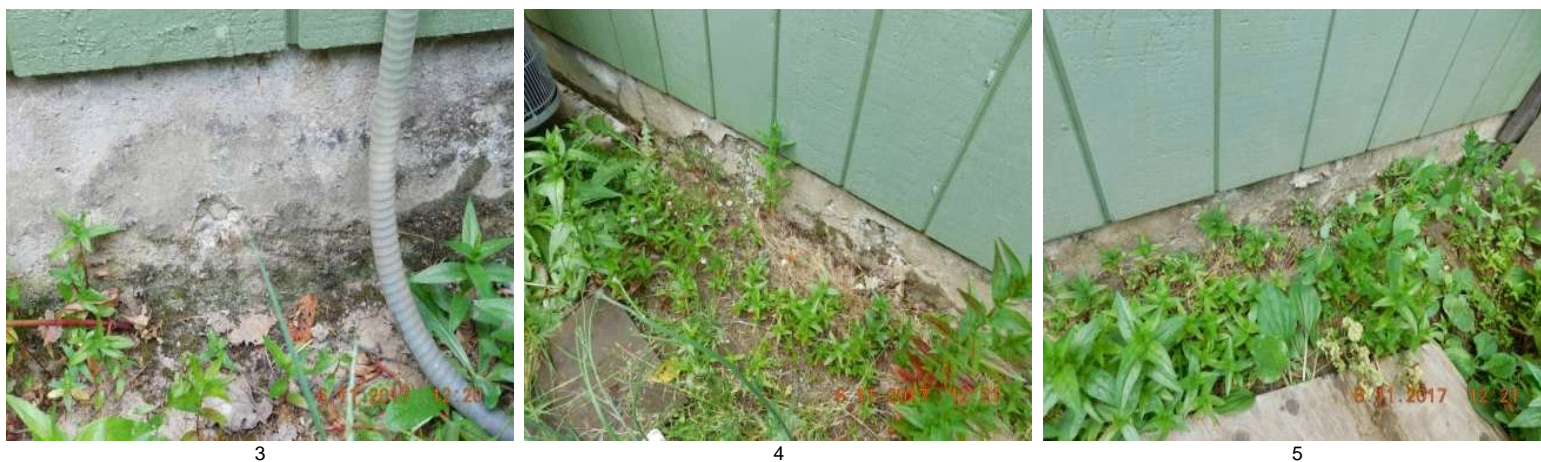
### 4.1.1 Some Deterioration (M)

The foundation appeared serviceable, however there is some age or freeze related deterioration.

**Suggested Action:** To prevent further deterioration of the foundation, manage the water around the exterior of the house. Ensure the slope of the ground is shedding water away from the house wherever possible, keep gutters clean and functional, do not over irrigate or allow sprinklers to spray the house.

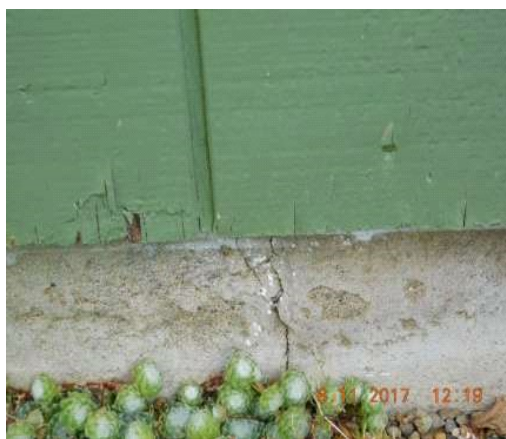
### 4.1.2 Common Cement Cracks

It is very common for a few thin cracks to be present in poured concrete foundations. These small cracks are not a problem. The cracks can be sealed to prevent water from easily entering into the crawlspace.

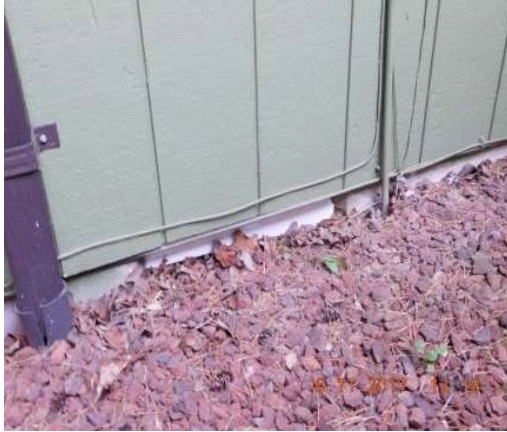
1

Consider insulating crawlspace under flooring and around water supply piping. Once well insulated, there will be less reason to ever block the vents.

Suggested Action: Keep vents open for as much of the year as possible to ensure proper ventilation. Close vents only during the coldest parts of the fall and winter seasons to protect pipes from freezing.

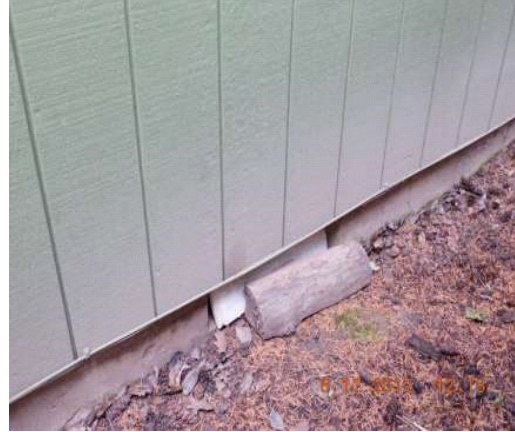
2

An unventilated crawlspace can allow moisture to accumulate, which could cause serious damage to framing and insulation, as well as encourage pest and WDI activity.

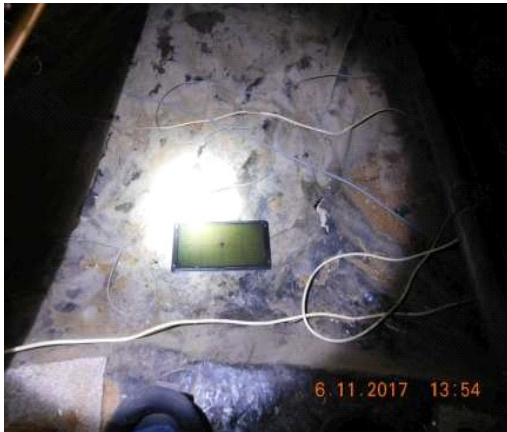
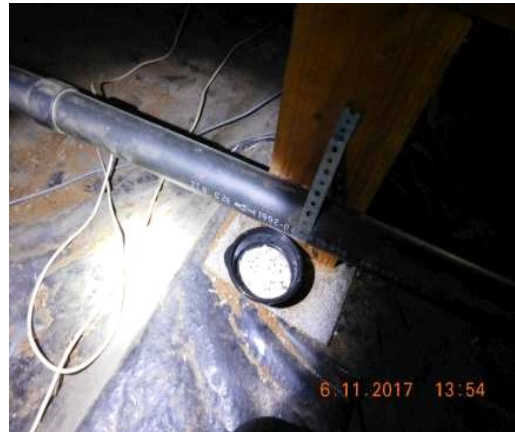
### 4.2.2 Pest Poison Present M P

Rodent poison and traps were noted in the crawlspace and the attic.

Suggested Action: Remove rodent poison from crawlspace.

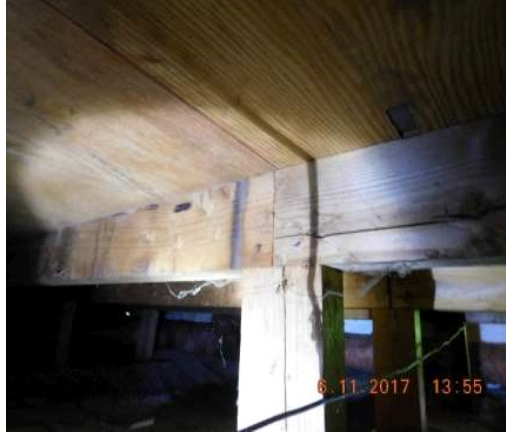
1

### 4.2.3 Gusset Plates Recommended U

To help hold the structure together during an earthquake, it is recommended that plates or brackets be attached at post to beam and beam to beam connections.

Suggested Action: Attach brackets or gusset plates at post to beam connections.

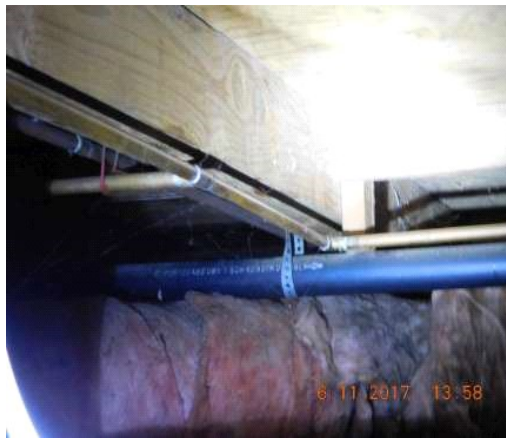
1

To protect pipes from freezing weather and to insulate the house from cold weather, close the crawlspace vents during freezing weather. (Keep the vents open as much of the year as possible to allow proper air flow through the crawlspace.)

Suggested Action: Close vents during coldest part of the year.  
Consider adding insulation around the piping.

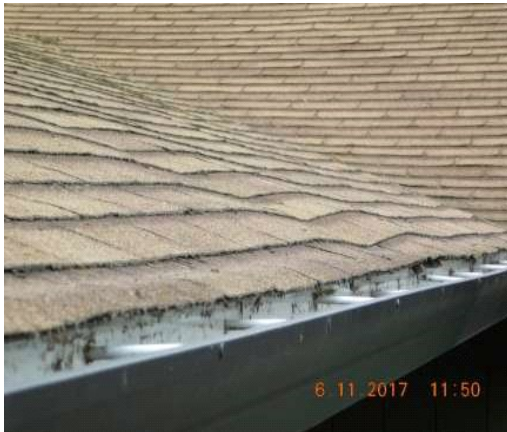
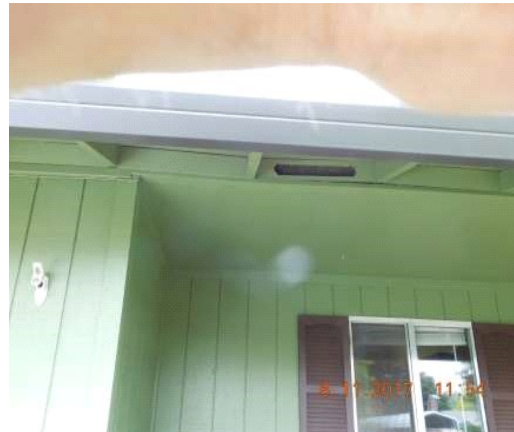
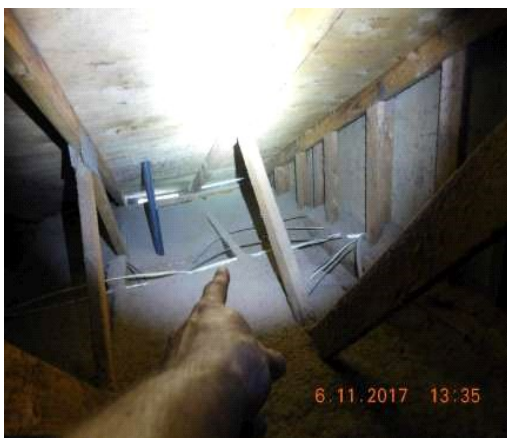
One of the trusses supporting the portion of roof hanging over the front porch was not engineered for this use. As a result, it is sagging relative to the properly engineered trusses.

Suggested Action: Jack up the sagging truss over the front porch and add framing to the truss (in the attic) to match the other properly engineered trusses.

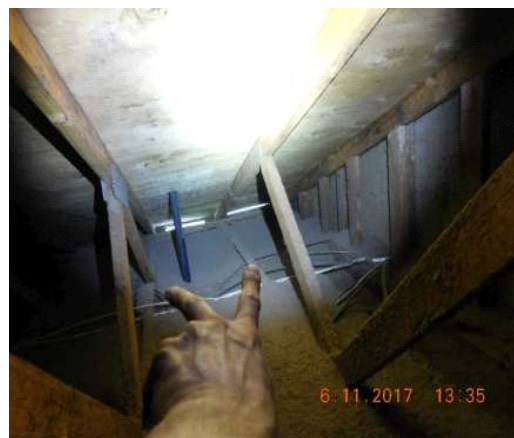
4

### 5.1.1 Improper Truss **E** **R**

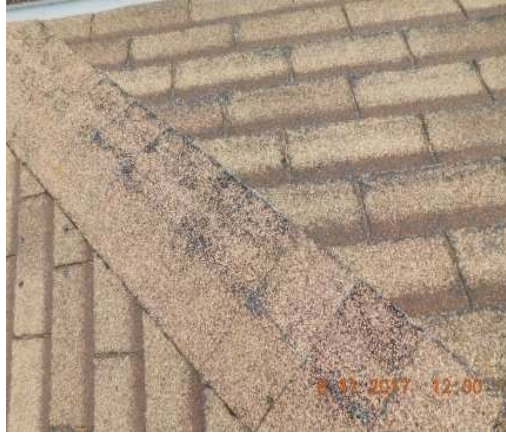
1

### 5.1.2 Moderate Shingle Deterioration **M**

The shingles are showing signs of aging. Usually the roof still has many years of life left but should be monitored more frequently for problems, such as torn or missing shingles.

Suggested Action: Monitor the roof for problems, such as torn or missing shingles.

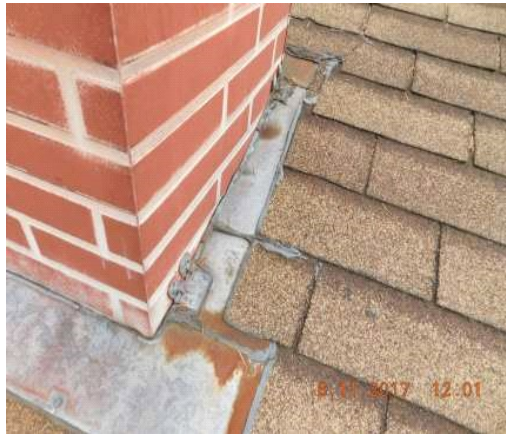
1

### 5.1.3 Flashing Around Chimney Relies On Sealant M

Sealant deteriorates relatively quickly.

Suggested Action: Monitor and maintain sealant around chimney.

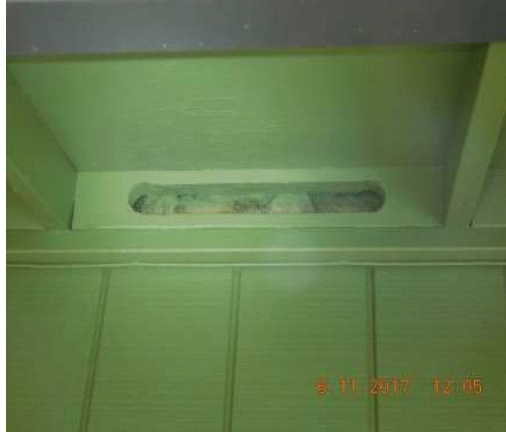
1

### 5.3.1 Ventilation Blocked M

The garage attic eave vents are blocked. Since the attic in this portion of the house is open to the garage, this is not a significant issue.

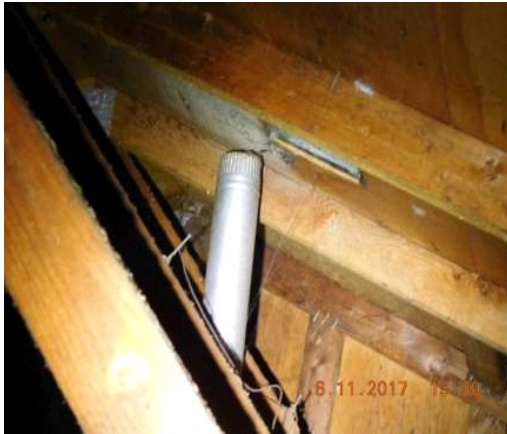
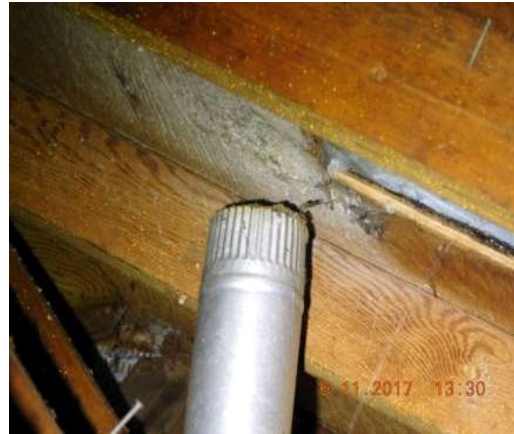
To prevent moisture build-up in the attic and clogged attic vent screens, ensure fan ducting exhausts all the way to the exterior.

This often results in or contributes to mold and mildew growth in the attic. When moisture issues are severe enough, the roof sheathing can also be damaged.

Suggested Action: Route the ducts all the way to dedicated, sealed terminations at the gable walls or through new roof penetrations (Do not seal the existing attic ventilation).

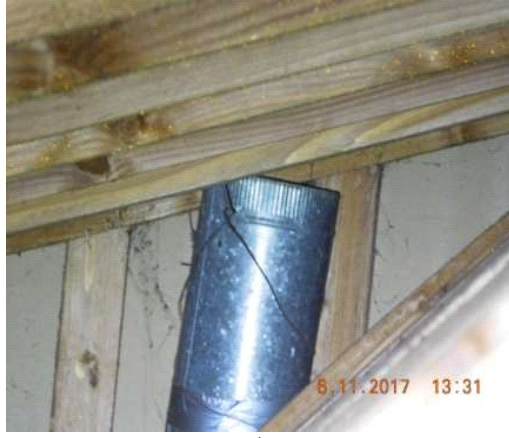
Grease may accumulate in the attic area, creating a fire hazard.

Ensure the ducts carry the exhaust all the way to the exterior. Makeshift systems that attempt to seal against wood sheathing are typically not permanently effective and should be avoided.

Suggested Action: Ensure the kitchen fan duct carries the exhaust all the way to the exterior through a dedicated, sealed flashing designed for that use.

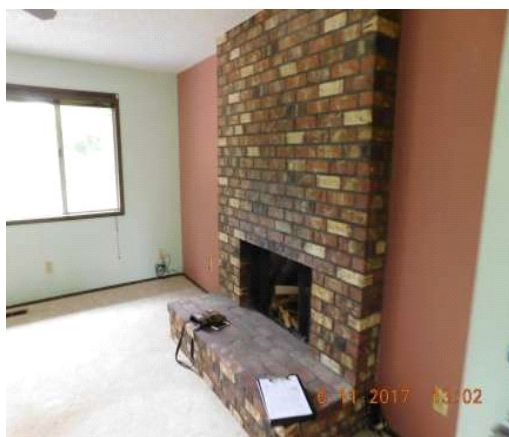
1

### 6.2.1 Unlabeled Wood Burning Device

As of August 1, 2010, Oregon law requires all sellers of "residential structures" to remove and destroy uncertified solid fuel burning devices, such as woodstoves or fireplace inserts prior to closing of the sale.

A stove must be properly labeled to be considered certified.

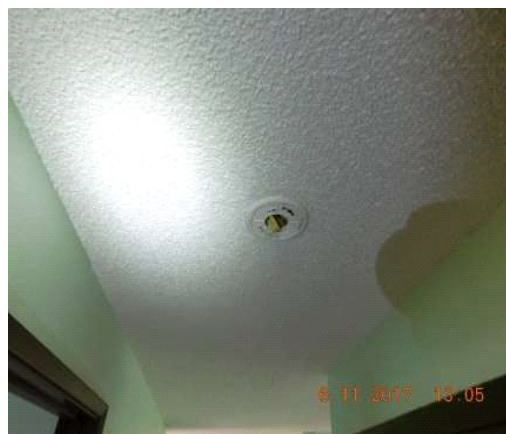
1

### 6.3.1 Smoke Detector Unit Missing

Suggested Action: Replace the missing smoke detector(s).

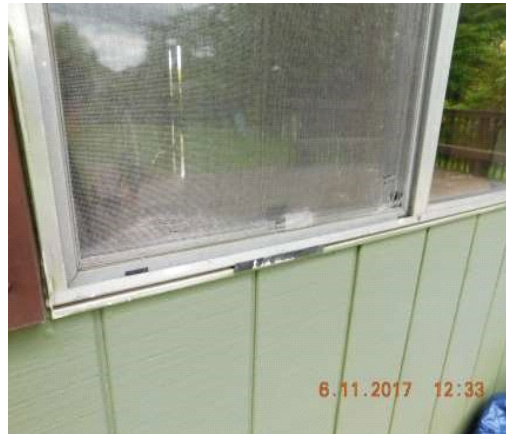
1

### 7.1.1 Screens Damaged M

Suggested Action: Repair screens.

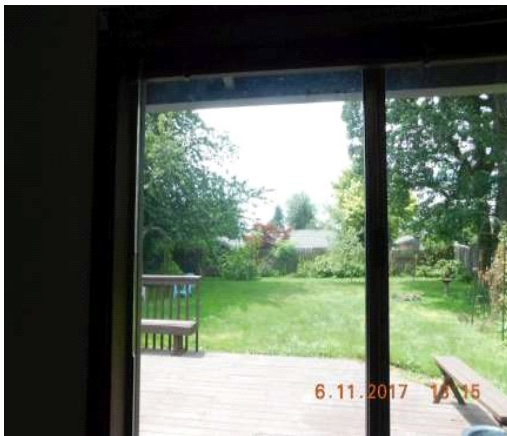
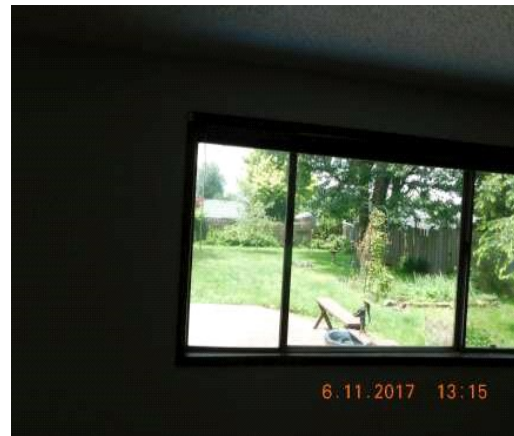
### 7.1.2 Dual Glazing Failed M

The seal has failed and let the gas leak out from between the window panes, lowering the thermal insulation. This also allows an inaccessible fog to form.

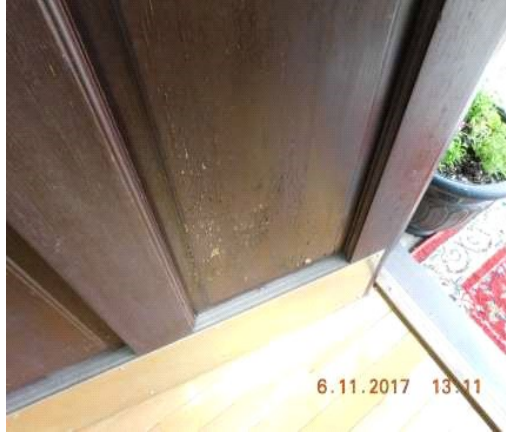
1

### 7.2.1 Cosmetic Issues

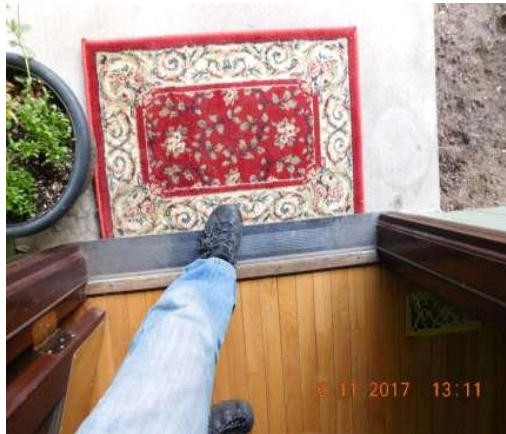
1

### 7.2.2 Threshold Not Fully Supported M

Suggested Action: To minimize future damage, provide full support under exterior door thresholds.

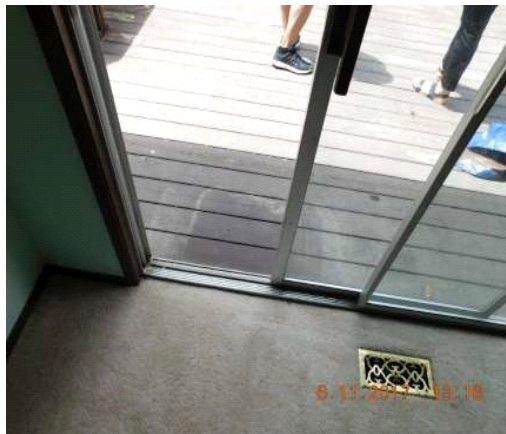
1

### 7.2.3 Screen Missing M

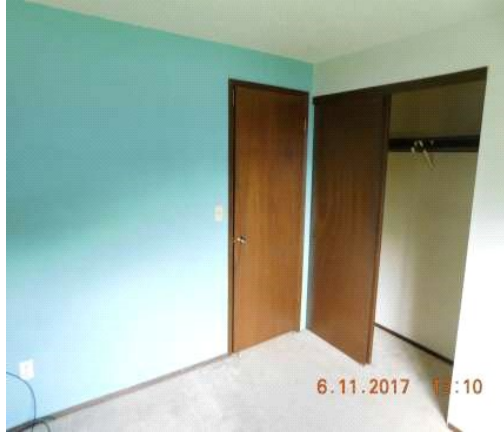
1

### 7.3.1 Door Does Not Latch M

Suggested Action: Ensure all doors properly latch when closed.

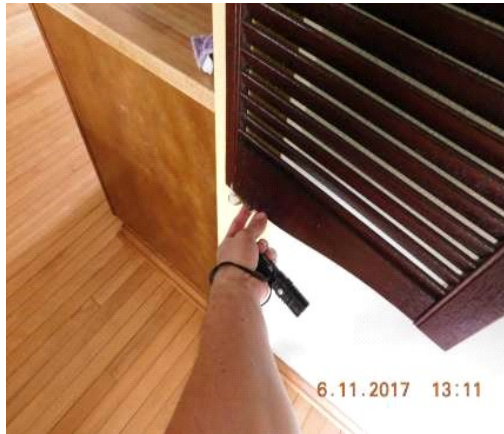
1

### 7.3.2 Hardware Issues M

Suggested Action: Ensure all door hardware is present and functional.

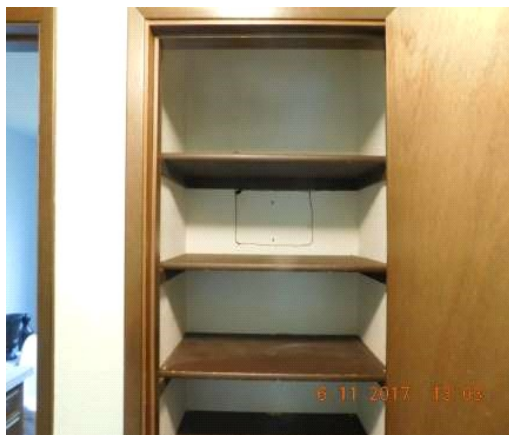
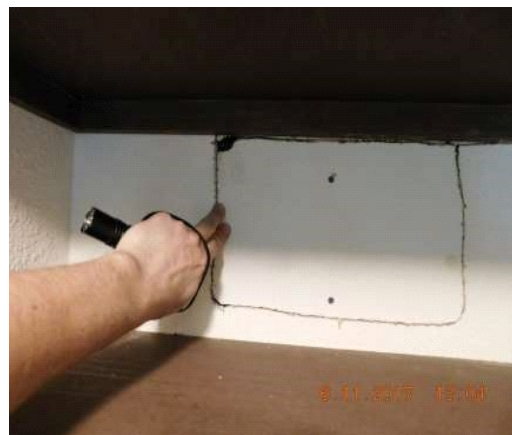
### 7.4.1 Unprofessional Patching M

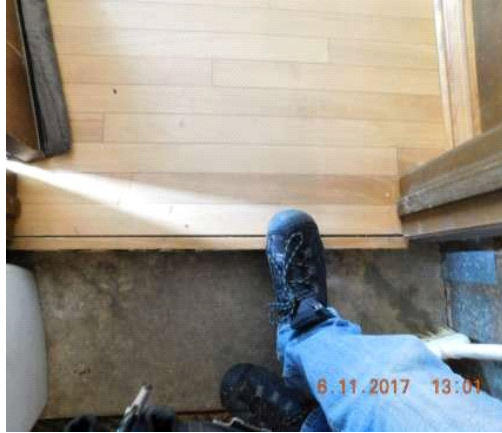
1

### 7.5.1 Threshold Loose

Suggested Action: Secure the loose flooring threshold at garage door.

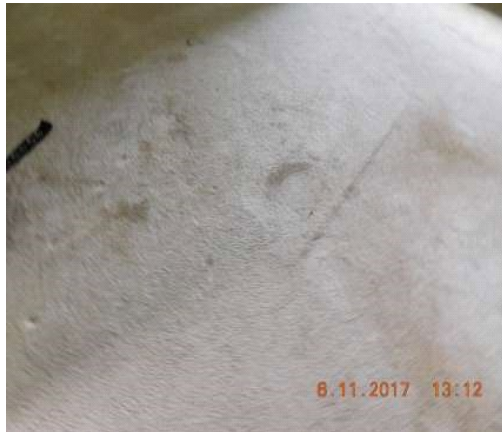
1

### 7.5.2 Cosmetic Issues

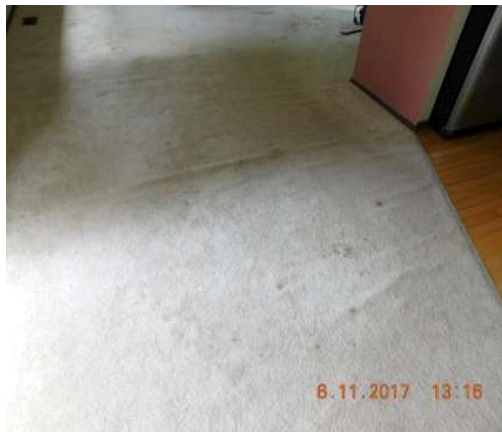
1

### 7.5.3 Carpet Loose

Loose carpet can be a trip hazard.

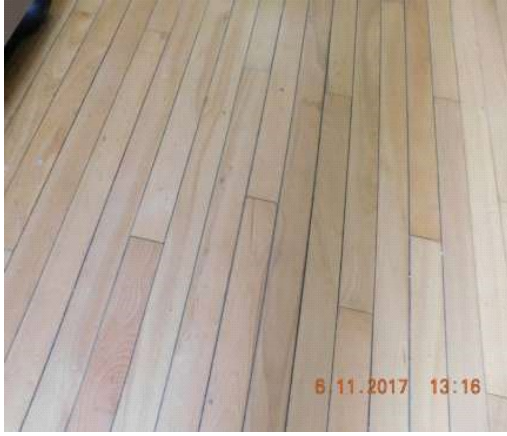
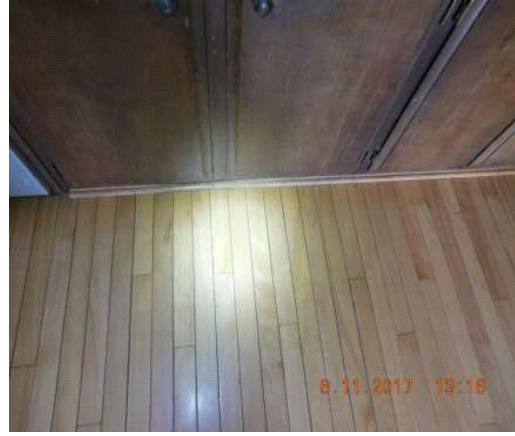
### 7.5.4 Water Damage

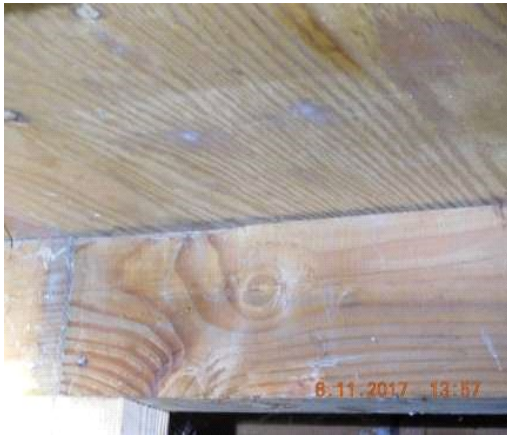
7.5.5 Creaky (M)

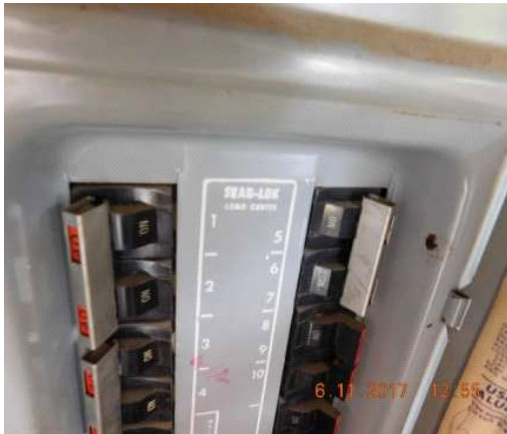
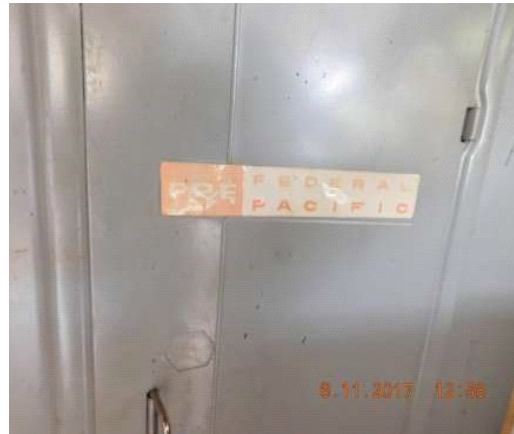
[http://inspectapedia.com/fpe/FPE\\_Stab\\_Lok\\_Hazards.php](http://inspectapedia.com/fpe/FPE_Stab_Lok_Hazards.php)

Suggested Action: Contact a licensed electrician to replace the Federal Pacific Stab-lok Panel.

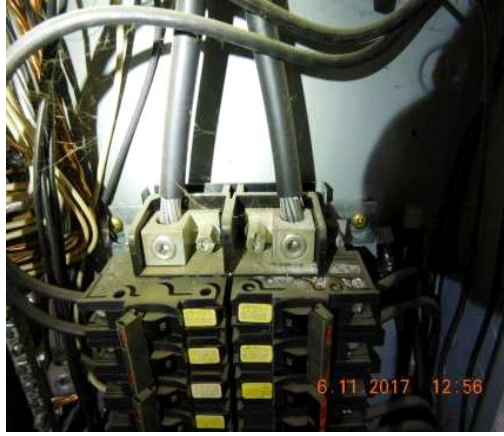
1

### 8.2.2 Anti-oxidant Paste Missing

Aluminum wires can sometimes corrode and cause arcing when not protected with anti-oxidant.

Suggested Action: Have a licensed electrician apply anti-oxidant paste to aluminum conductors in the electrical panel.

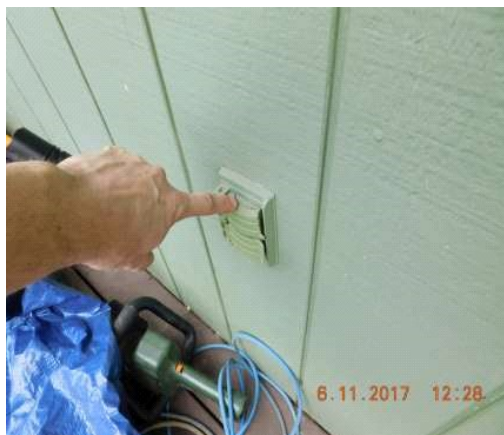
1

### 8.3.2 Exterior Outlet Cover Damaged

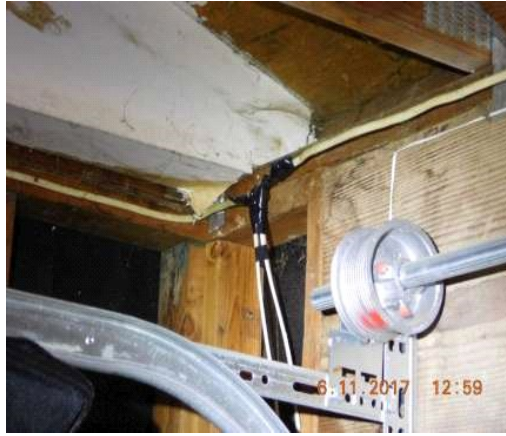
1

### 8.3.3 Wiring Junctions/terminations Not Protected

All terminations and connections must be inside a covered electrical box.

Suggested Action: Properly protect wiring junctions and terminations in covered electrical boxes. Condition noted in garage.

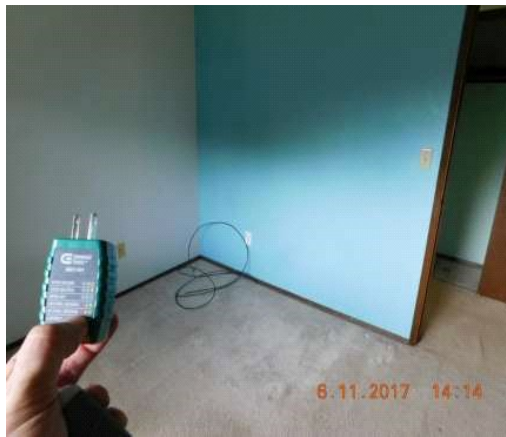
1

### 8.3.4 Outlet Hot / Ground Reversed

Suggested Action: Ensure all electrical receptacle outlets are properly wired. (At least one outlet was noted as miswired.)

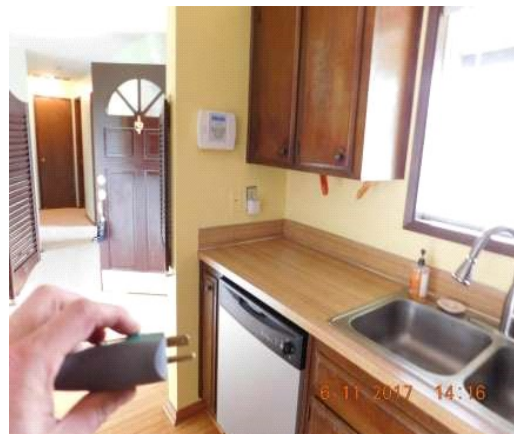
2

### 8.3.5 Recommend GFCI

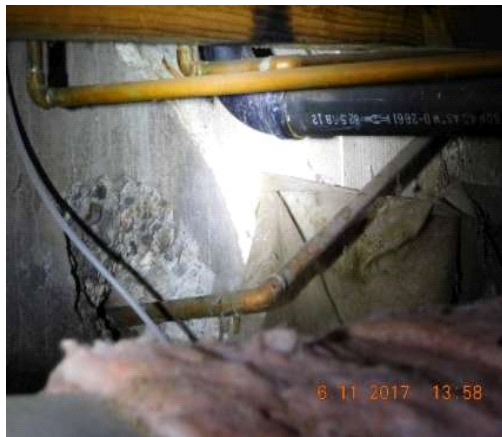
1

### 9.1.1 Insulation Missing

Suggested Action: Insulate the main water supply line in the crawlspace, or block vents during freezing weather.

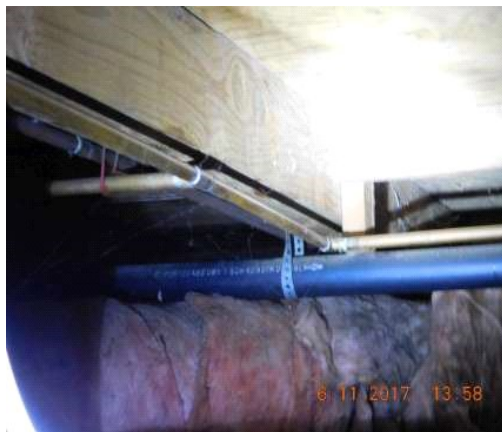
1

To minimize the risk of burst pipes during freezing weather, ensure all supply piping in the crawlspace is insulated or close crawlspace vents during (and only during) the coldest days of the year.

Suggested Action: Ensure all supply piping in crawlspace is insulated.

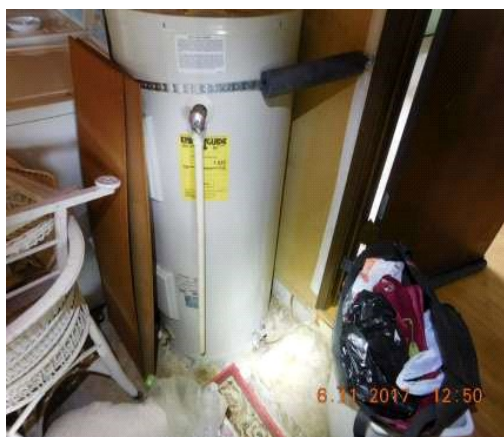
1

Unsecured water heaters may move enough during an earthquake to pull water and electrical or gas lines loose.

Suggested Action: There should be a strap securing the water heater at the upper third and a strap at the bottom third.

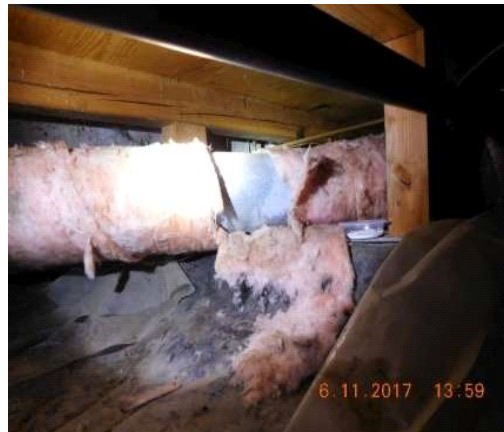
1

### 10.1.1 Crawlspace Duct Insulation Damaged/missing

Suggested Action: Ensure all central air ducting in the crawlspace is insulated.

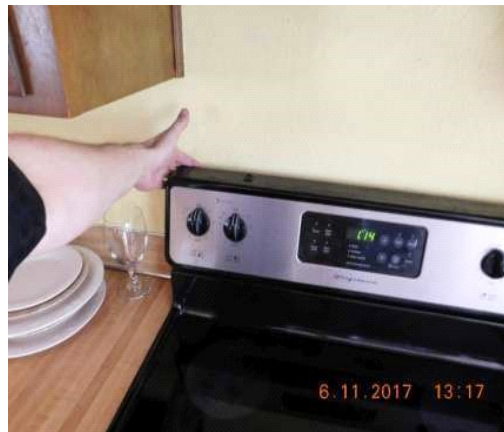
Anti-tip devices prevent the range from tipping, or its contents from spilling, should a child attempt to climb on it or its open door. This is a recommended safety feature that is important particularly if small children reside at or visit the residence.

Suggested Action: Install an anti-tip bracket for the stove.

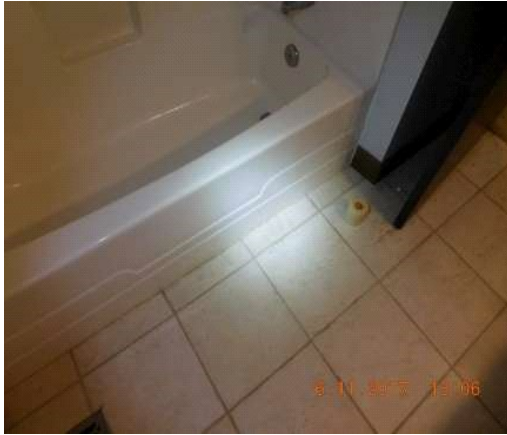
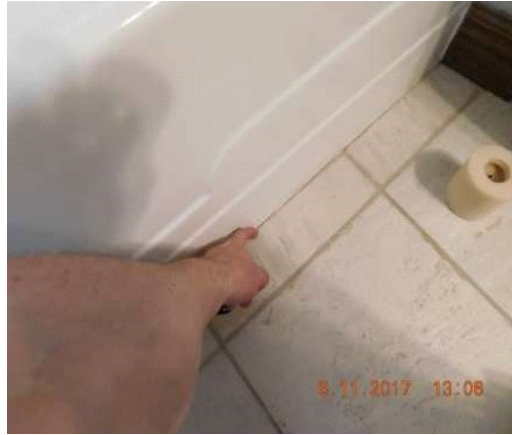
Caulk is flexible and won't crack and break up like grout will in these areas.

Suggested Action: Replace grout with caulking where surface planes meet.

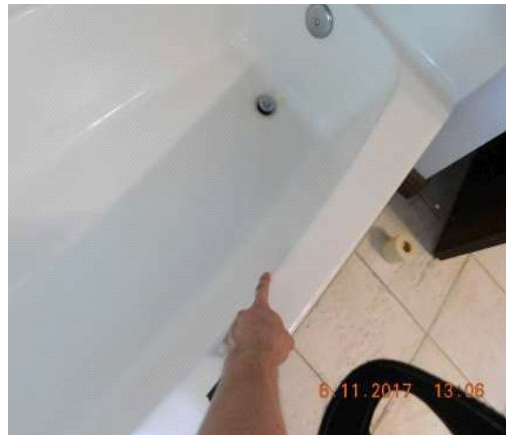
1

#### 12.1.2 Tub/Shower Surface Damaged <sup>Ⓜ</sup>

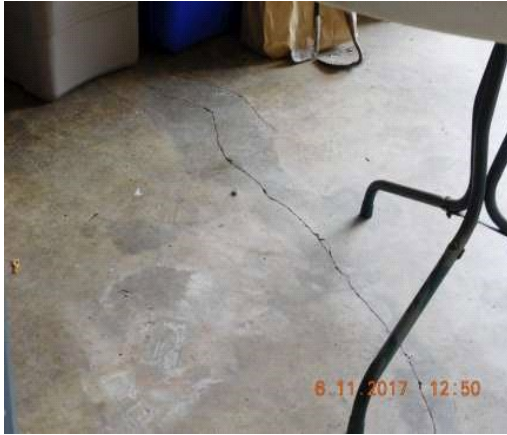
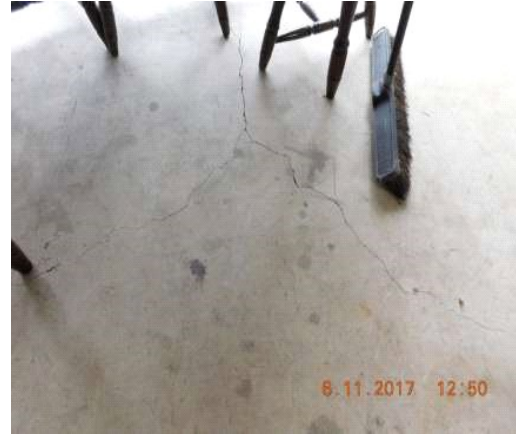
It is very common for garage slabs have unsightly cracks, especially if control joints were installed when the slab was poured.

These are typically caused by expansion of the supporting soil below when it gets damp. This is usually a cosmetic issue and not indicative of a condition of concern.

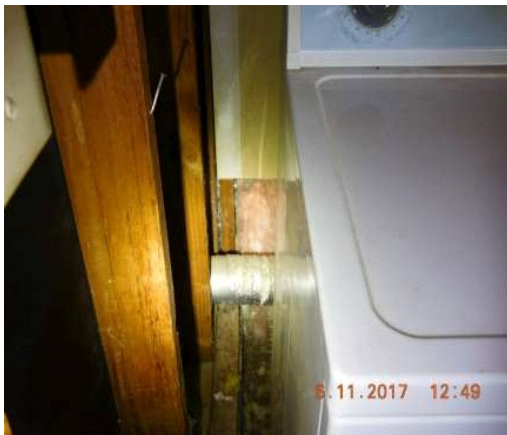
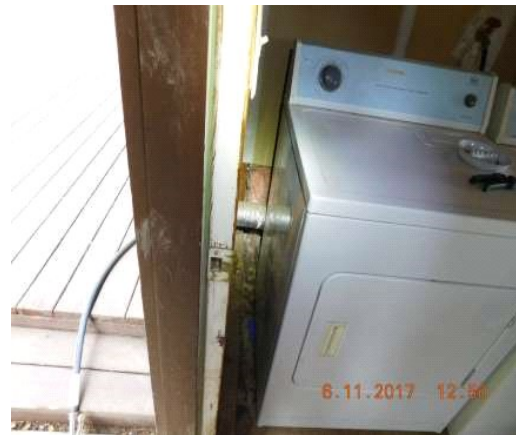
Holes or damage to the sheetrock may allow fire or toxic vapor to spread and should be properly patched or sealed.

Suggested Action: Seal any gaps in the fire separation.

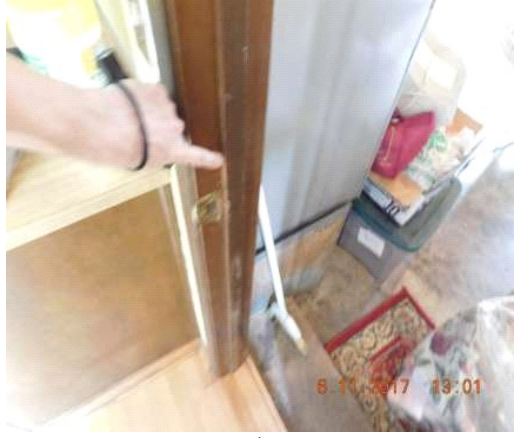
### 13.2.2 Fire Door Weatherstripping Missing R S

Fire door weatherstripping should be present and intact to prevent toxic vapors from entering the dwelling in the event of a garage fire.

Suggested Action: Ensure weatherstripping at the fire door (between the garage and the dwelling) is present and functional.
