#### **Portland Home Inspect**

# Property Inspection Report for: 123 Main St, Aloha, OR 97084

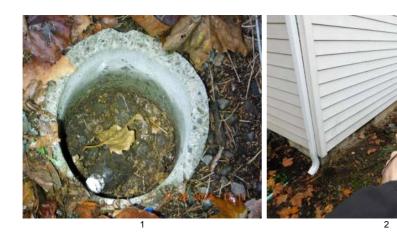
#### 1.1.1 Pit Functionality Unclear

This pit is filled with earth/debris and it is not obvious to inspector what it is for or what it contains.

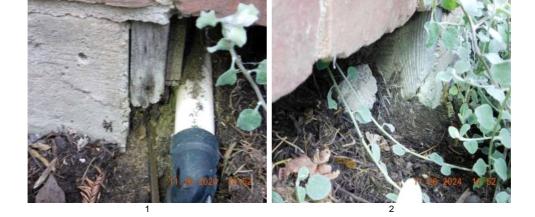
#### Rot At Vent Frame(s) 4.2.1

The wooden frame(s) around the crawlspace vents have been in contact with earth or debris and have been damaged. Suggested Action: Replace rotten vent frames and ensure the frames are clear from contact with earth and debris.

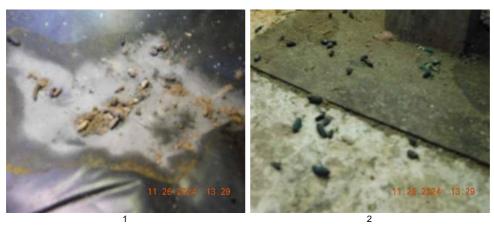
#### **Evidence Of Pests - Rodents** 4.2.9

Significant evidence of rodents was found in the crawlspace.

Entering a crawlspace with significant rodent fouling poses several health and safety risks. Rodent droppings, urine, and nesting materials can carry harmful pathogens, including Hantavirus, Leptospirosis, and Salmonella, which can cause serious illnesses when inhaled or contacted.

Given these risks, it's crucial to avoid entering such spaces and instead, recommend professional pest control and cleanup services to ensure safety and proper remediation.

Another action to consider: Contact a pest control professional to ensure there is no current rodent

Clean the crawlspace of rodent debris and sanitize the crawlspace.

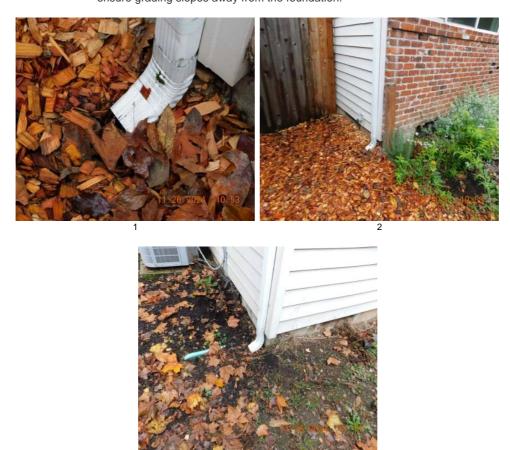
### 5.2.2 Downspouts Drain Close To House 🚇

Water that accumulates near the foundation may enter the crawlspace/basement or case erosion under foundation footings.

Suggested Action: Monitor to ensure rainwater from downspouts does not enter the crawlspace / basement.

Another action to consider: Route water from the downspouts well away from the home and ensure grading slopes away from the foundation.

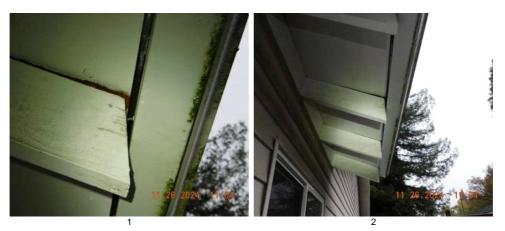
#### 5.2.3 Unprofessional Installation M

Items that are not professionally installed are more likely to be defective or cause unexpected problems.

Suggested Action: Monitor the gutters to ensure they are effective.

Another action to consider: Professionally reinstall the gutters.

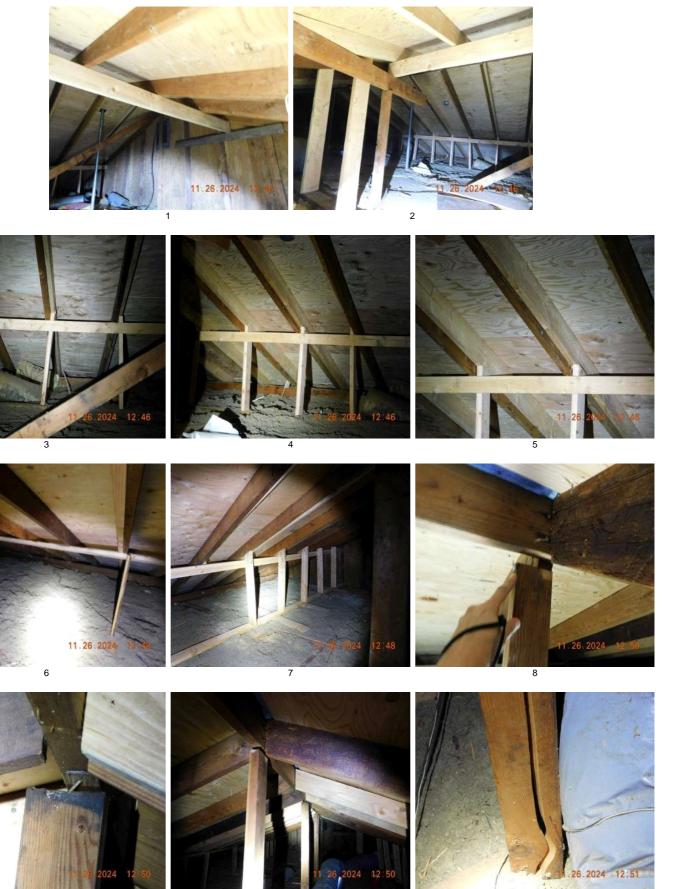
There appears to have been significant structural issues with both framing and sheathing. Repairs have been made to rafters and support, and much of the sheathing was replaced. Some old damaged/loose supports were noted.

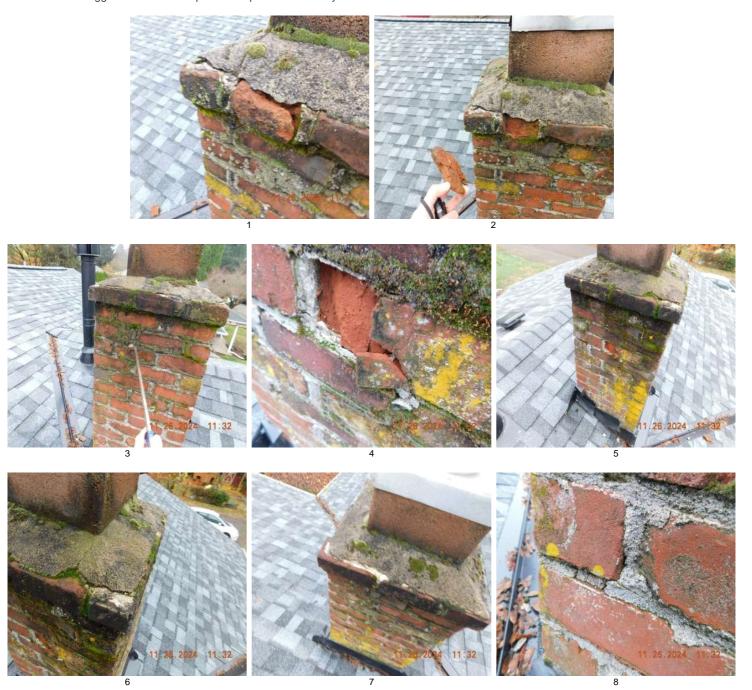
#### Deterioration ® 6.1.1

Damaged bricks, deteriorated mortar and crown.

Suggested Action: Repair and repoint the chimney.

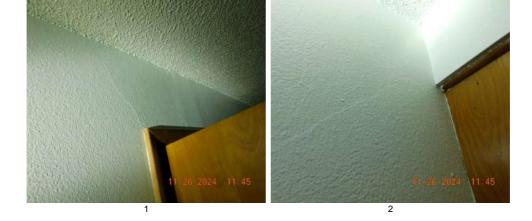
### 7.4.1 Common Stress Cracks 🚇

It is very common to see some cracking due to minor settling of the framing.

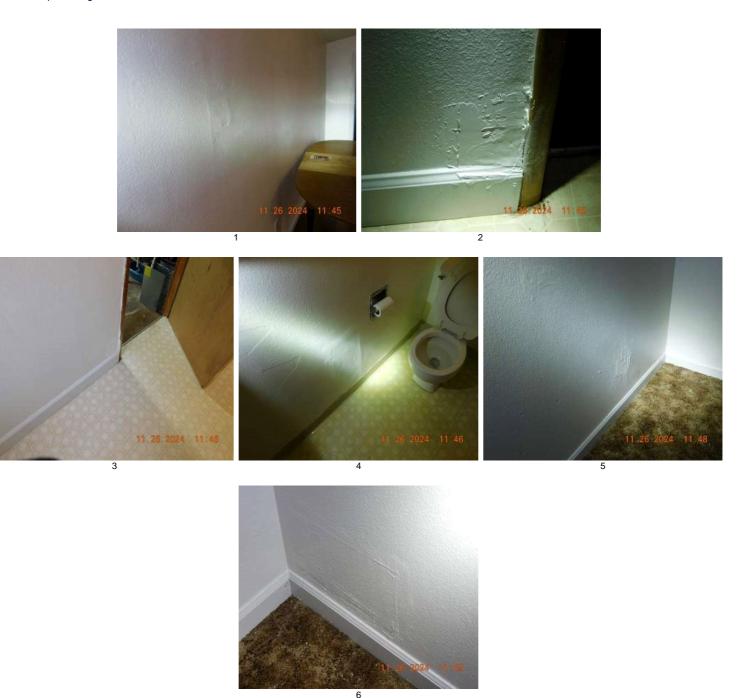
## 7.4.2 Patches M

Patches usually are just a cosmetic issue, but may indicate a prior issue inside the walls or damage caused by past leaking from the roof or plumbing.

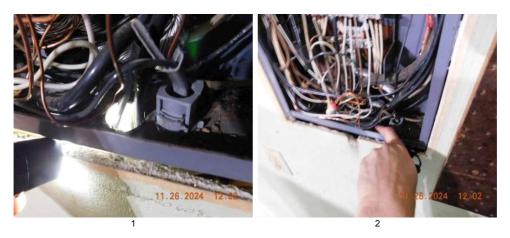
# 8.2.4 Bushing Missing At Electrical Box (8)

There is wiring entering the panel without the proper protective bushing. Wiring that enters the panel should be solidly anchored and protected where it enters the panel to prevent the sharp edges of the panel box from damaging the wiring and creating an equipment/safety hazard.

Suggested Action: Install bushings to protect wiring as it enters the electrical panel.
